September 23, 2013

Re: University of California Seismic Rating for 1035-1045 Gayley Avenue, Los Angeles

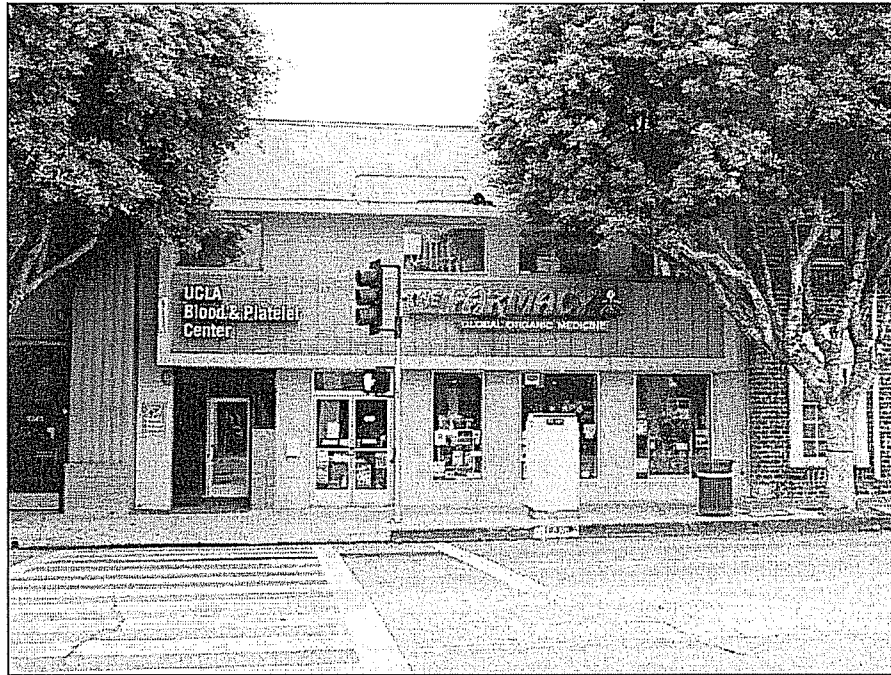
Photo 1 – Gayley Avenue Elevation

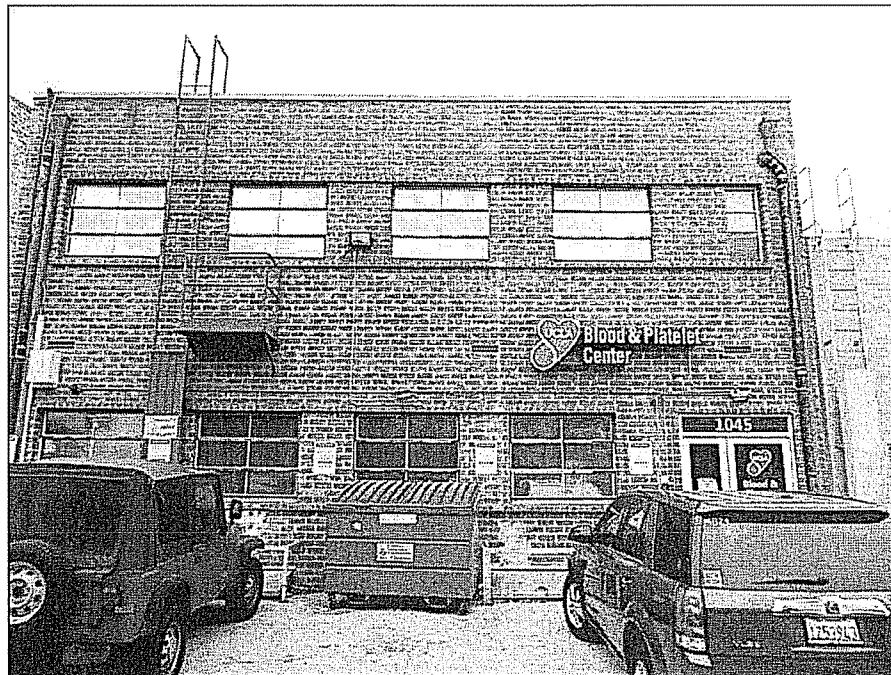
Photo 2 – West Elevation

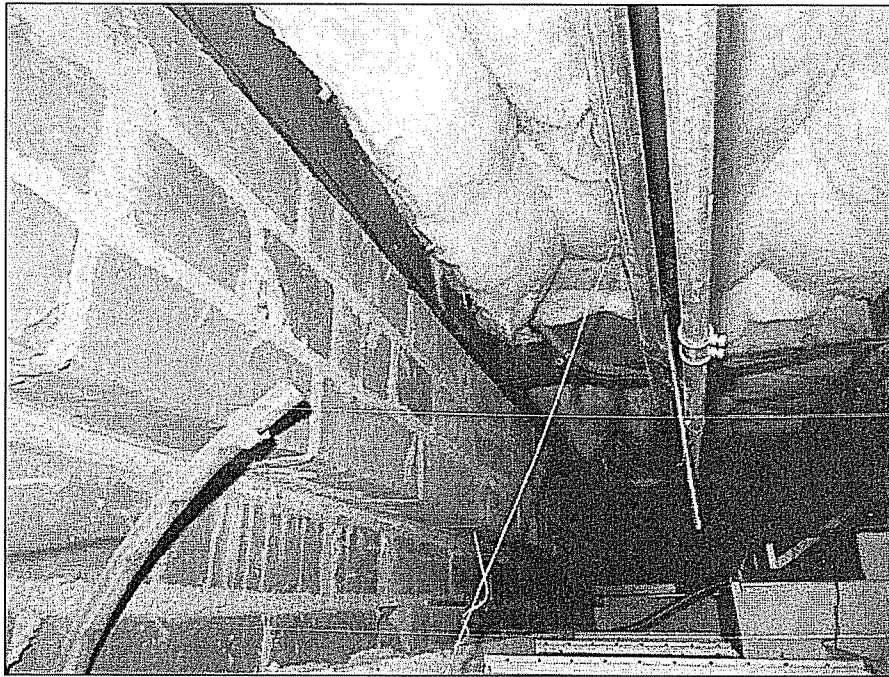
The building has a complete load path to transfer seismic forces to the foundations. There are no significant strength or stiffness discontinuities in the reinforced brick masonry walls. The walls provide adequate strength and redundancy to resist expected seismic force (see attached calculations). Out-of-plane anchors and straps tying the exterior brick walls to the wood roof and floor framing were observed (see photos).

Photo 4 – Strap Connecting Wood Framing to Brick Wall

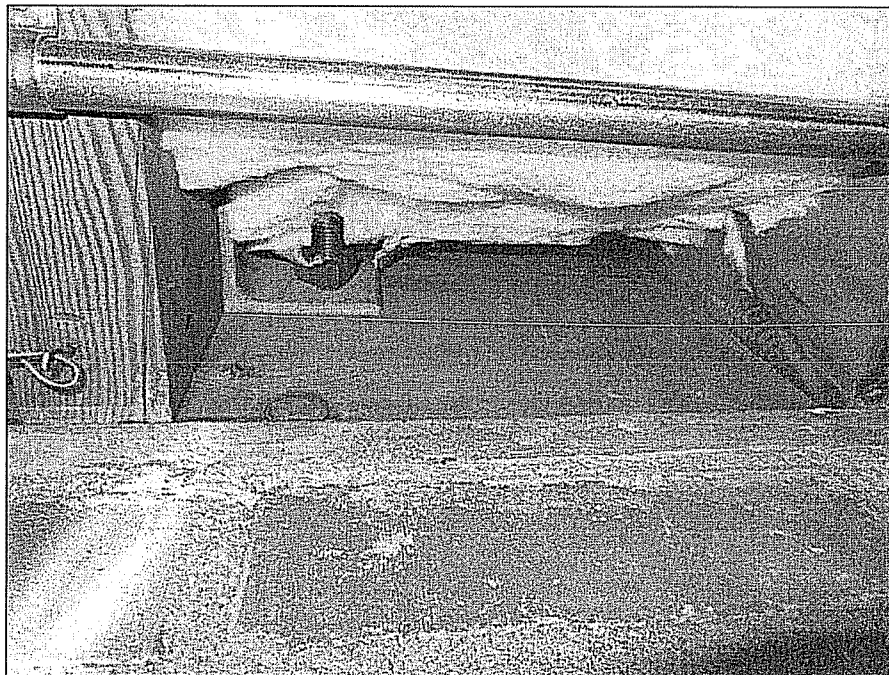
Photo 4 – Out-of-plane Wall Anchorage
